TREATMENT METHOD FOR LEAKAGE OF EXPANSION JOINTS IN SEDIMENTATION TANKS OF WATER PLANTS

Taking the leakage maintenance project of the sedimentation tank of Shanghai Qingpu Water Plant as an example, the specific reasons for the leakage of the sedimentation tank are analyzed. According to the existing construction technology and experience, the treatment method of embedded water expansion strips is adopted to prevent seepage. The effect of leakage, the treatment method is summarized and improvement measures are put forward. This kind of construction plan has certain promotion value.

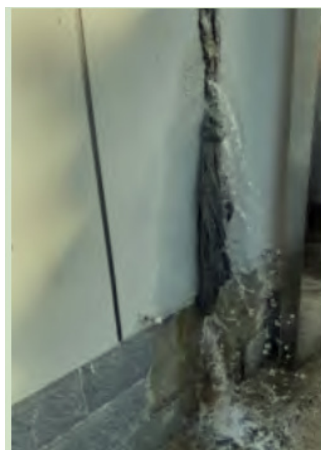
Figure 1: Expansion joint leakage

settlement occurred vertically [1]. On the plane, the side wall plate appears dislocation inside and outside the tank, and the phenomenon of differential settlement occurs vertically. Figure 1: the leakage position appears at the connection position of the sedimentation tank at the expansion joint, the connection position of the channel, and the position of the sludge discharge valve. No. 5 to No. 7 sedimentation tanks have leakage, among which No. 6 and No.7 sedimentation tanks have serious leakage, and there is water column leakage at the bottom of the expansion joint of the wall plate [2, 3].

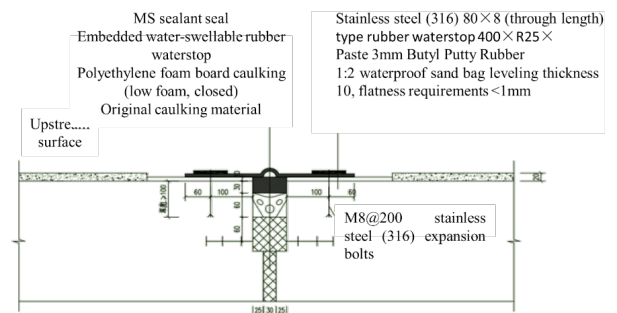
Figure 2: Construction drawings.

Remove the foam filler in the original expansion joint with a depth of 10cm on the inner surface, clean and trim the gap with an electric hammer, keep the concrete edges on both sides of the expansion joint on the inner surface of the joint parallel, and chamfer the corners of the structure to ensure that the compressed sealing body is in It can play the sealing function in a large range and adapt to the settlement and deformation of the seam Figure 2.

Press the water-swellable rubber waterstop into the repaired seam.

Seal with MS sealant on the water-swellable rubber waterstop.

Butyl putty leveling construction.

Attach the omega back stick waterstop.

A stainless steel pressure plate is added to the water stop, and expansion bolts are inserted on both sides to fix it.

Cover with quick-setting rubber to seal.

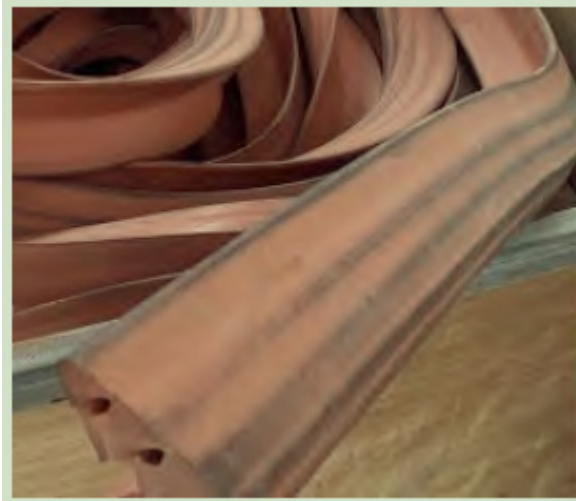
Figure 3: Water-swellable adhesive strip.

Figure 3-6: after all pressure grouting is completed, a period of maintenance is required to ensure that the grouting is firm. At the same time, check whether the purchased rubber strips meet the requirements. After passing the inspection, start the construction of the water-swellable rubber strips and MS sealant.

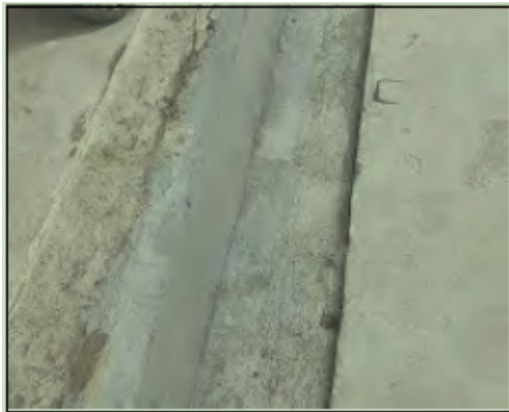
Figure 4: Double packet (MS) sealant application

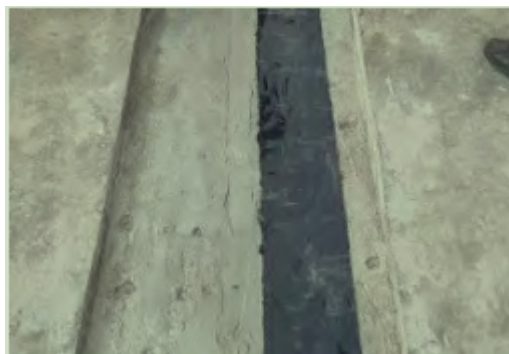
Figure 5: Butyl tape

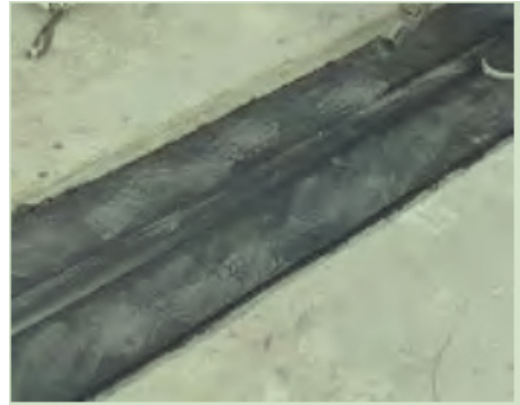
Figure 6: EPDM Ω-shaped waterstop

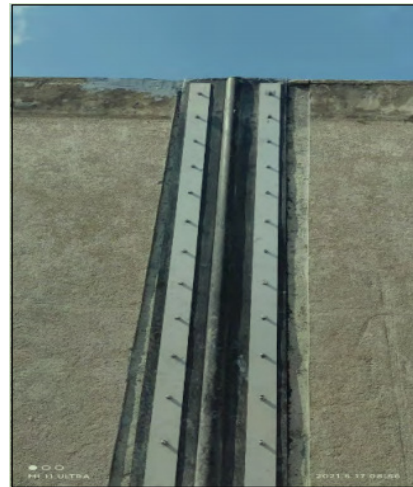
Figure 7: The construction of stainless steel bead is completed.

When carrying out the construction of stainless steel beading, it is necessary to confirm the screw type and size with the material supplier in advance, and the construction can be carried out only after meeting the requirements. When ready, drill holes first, then use air pipes and wire brushes to clean up debris, and finally inject glue and screw into the screw. It should be noted that the newly arrived chemical bolt glue must be suitable for wet environment, bolt and bead construction Figure 7.

When tightening, the loose screws should be pulled out in time, and the bolts should be re-inserted after the accumulated water has been treated. After the bolts in the pool are all tightened at the top of the water stop, cut them at a uniform height and seal them with sealing compound. The full water test can be performed after all adhesive strips are laid, stainless steel platens are placed, and chemical bolts are tightened.

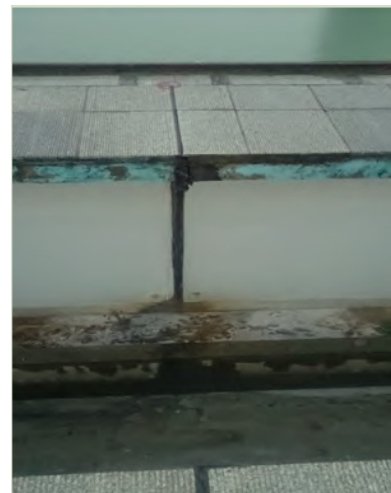
Figure 8: No leakage point for 24 hours at full water level.

After the expansion joint of the sedimentation tank has completed all the procedures, the full water test will be carried out. After the test starts, it is necessary to strictly abide by the relevant provisions of the "Full Water Test Safety Technical Disclosure.pdf" to ensure the smooth progress of the test. Figure 8: after a 24-hour full water test, it was observed that the repair effect was very good, and there was no leakage in the full water test.

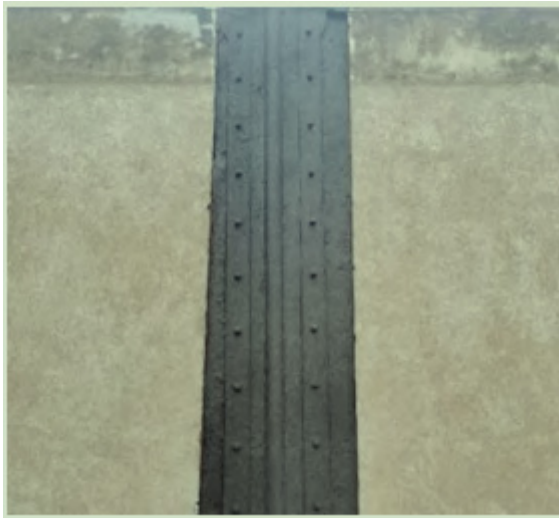
Figure 9: Waterproof paint coating

After the sedimentation tank is full of water, open the valve to drain the water and carry out the waterproof and anti-corrosion treatment of the expansion joint. Before drainage, it is necessary to check again whether there is leakage in each expansion joint. Figure 9: after the inspection is correct, carry out waterproof and anti-corrosion treatment on each expansion joint.

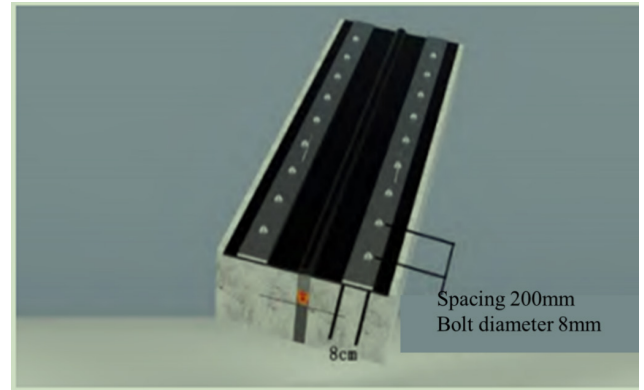
Figure 10: Schematic diagram of the opening of the stainless steel pressing plate in the original scheme

Figure 10, 11: after the implementation of the No. 7 sedimentation tank maintenance plan, the experience was summed up and relevant improvement suggestions were put forward. In the original plugging maintenance plan, a stainless steel pressure plate with a width of 8cm was used on the water stop, and the bolts on the stainless steel pressure plate were 8mm in diameter with a single row spacing. 20cm in-line layout, I suggest to widen the stainless steel pressure plate to a width of 12cm, and change the bolts to double-row toothed bolts with a diameter of 10mm and a spacing of 15cm.

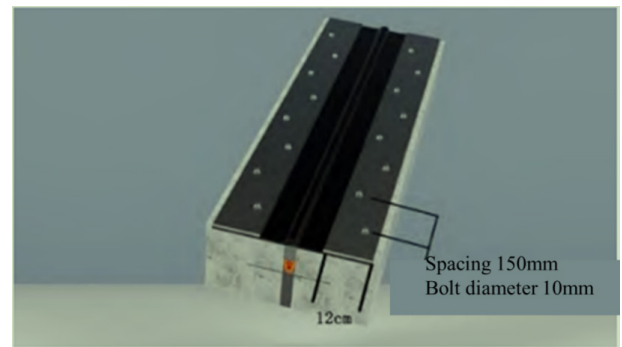
Figure 11: Schematic diagram of the opening of the stainless steel pressure plate in the revised scheme

This improvement has the following advantages: the diameter of the

bolts is increased, and the fixing is more firm; the distance between the bolts is reduced, and the bolts are arranged more densely. In the new scheme, after a certain screw is loosened, the distance between the nearest useful bolts is 30cm, the distance is shorter and the pressure is firmer; the bolts are changed to double-row tooth arrangement, the fixed area is enlarged, and the waterstop is pressed more firmly; stainless steel pressure plate Widening helps hold down the waterstop.
