RESEARCH ON THE APPLICATION OF SAND MIST SEAL TECHNOLOGY IN THE PREVENTIVE MAINTENANCE OF ASPHALT PAVEMENT IN AUTOMOBILE TEST FIELD

Christos Makropoulos*

Faculty of Engineering and Informatics, University of Bradford, Bradford BD7 1DP, United Kingdom

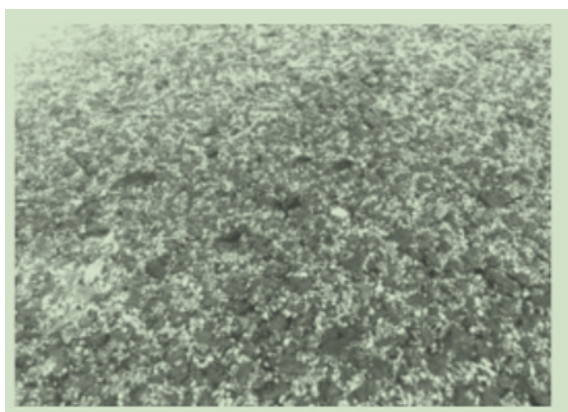
Figure 1: Photo of the original road

The high-speed loop test road has been in use since 2015. In 2020, the survey and statistics of the asphalt pavement conditions of the high-speed ring road will be carried out. A number of tiny cracks and the aging and peeling of the asphalt membrane were found (Figure 1). No major network cracks, cracks, ruts and other diseases were found. In order to prevent the development of early disease from affecting the overall structure of the pavement, small cracks in the pavement are closed. In order to maintain the driving safety of the test vehicle, it is necessary to maintain the anti-skid performance of the original road surface. A new type of resin-based sand-containing mist seal material provided

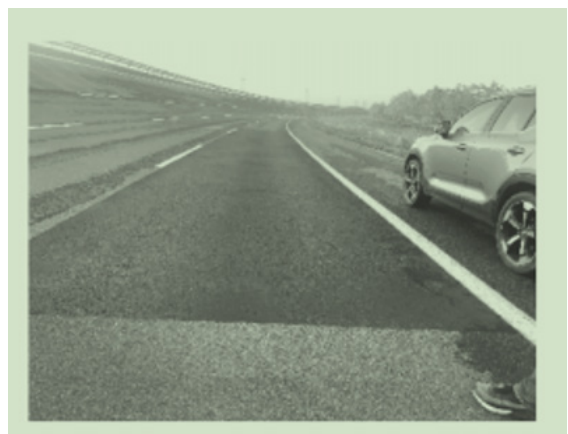
Figure 2: Photo after preventive maintenance

In addition, Yancheng is located in the transition zone from north subtropical climate to warm temperate climate. Has transitional features. And it is greatly influenced by the ocean, and the monsoon climate is more obvious. The wind is more northerly in winter and southerly in summer [4]. It is easy to entrain sea salt in the wind and rain, causing salt corrosion to the road surface for a long time. The temperature in winter is mostly between -5 and 5°C. The high-speed loop test belt is prone to icing on the shady side in winter. It poses a serious safety hazard to the test drive. After preventive maintenance, the road surface indicators meet the needs of vehicle testing (as shown in Figure 2).

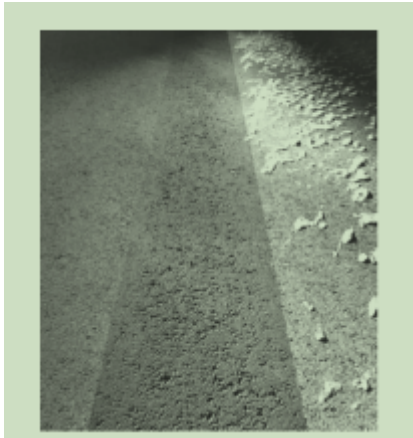
Figure 3: Anti-icing effect

This time, on the shady side of the high-speed ring road, which is prone to freezing in winter and low temperature weather, a section of sand-containing fog sealing material was implemented. The anti-icing effect was observed in the winter of 2020 at -6°C. The observed results are shown in Figure 3 below.

It can be seen from Figure 3 that there is no icing phenomenon in the road section where the sand mist seal layer is implemented. However, there is still ice on the road that has not been implemented. It can be proved that the resin-based sand mist sealing material of Thelma has a certain anti-icing effect. To a certain extent, the safety hazards of winter test driving can be eliminated.
